NATIONAL PHOTOGRAPHIC INTERPRETATION CENTER

First Surface Launch Test of WZ-1 Missile (SLBM-Related) Wuzhai Missile Test Complex, China (S)

25X1 IAR-0015/81 25X1 FEBRUARY 1981 Copy 170

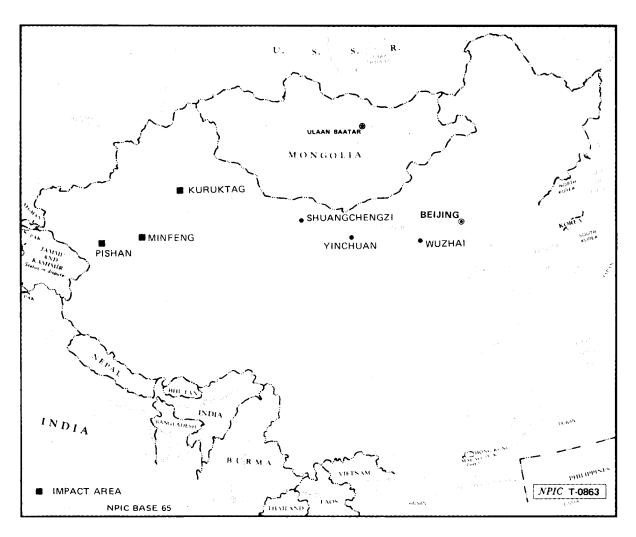
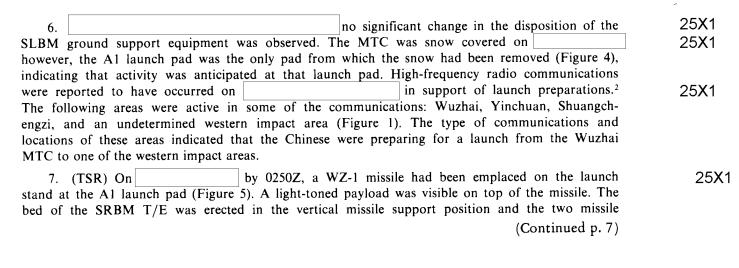
FIGURE 1. SLBM LAUNCH-RELATED FACILITIES. CHINA

1. (The first surface pad launch of a Wuzhai 1 (WZ-1; DEFSMAC designator for this vehicle is WU-1) solid propellant missile occurred on at the Wuzhai Missile Test Complex (MTC; China. Preparations for the launch were first identified in early December 1980 and culminated in a launch attempt from the A1 launch pad at Wuzhai SSM Research/Development/Training Launch Site A1/A2/A3 The submarine-launched ballistic missile (SLBM) land-based testing program has now entered the surface launch test phase at the Wuzhai MTC ¹ (Figure 1).	25X1 25X1 25X1 25X1
